Replace LH Front Drive Unit Clevis Mount and Both Front Halfshafts

Classification	Repair Bulletin	Section/Group	39 - Front Drive Unit	Country/Region	All
Year	2014 - 2019	Model	Model S, Model X	Version	Dual Motor

This Service Bulletin supersedes SB-19-39-001 R1, dated 5-Jun-19. Each content change is marked by a vertical line in the left margin. Discard the previous version and replace it with this one.

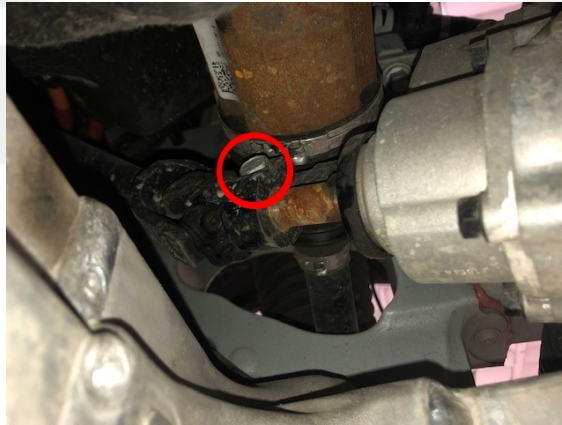
Figure 1

9. If equipped, remove the HEPA filter inlet duct (refer to Service Manual procedure 18105001).
10. If equipped, remove the HEPA filter outlet duct (refer to Service Manual procedure 18105202).
11. Disconnect 12V power (refer to Service Manual procedure 17010200).
12. If equipped, remove the HEPA filter housing (refer to Service Manual procedure 18100202).
13. Remove the front skidplate (refer to Service Manual procedure 30011002).
14. Drain the front gearbox fluid (refer to Service Manual procedure 39300102).
15. Remove the bolt that attaches the lower intermediate shaft to the steering rack (torque 30 Nm) (Figure 1), and then slide the shaft off the steering rack.

36. Position the LH and RH front wheels on the vehicle, and then loosely install the lug nuts.
37. Position the lower intermediate shaft on the steering rack, and then install the bolt that attaches the shaft to the steering rack (torque 30 Nm) (Figure 1).

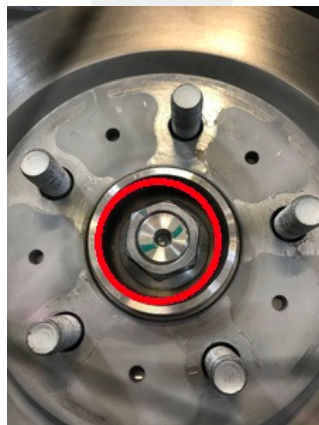
Figure 2

16. Remove the RH front wheel.
17. Remove the nut and discard the washer that attaches the RH halfshaft to the RH front hub assembly (Figure 2).

NOTE: The washer must be discarded and replaced with a new washer. The nut may be reused.

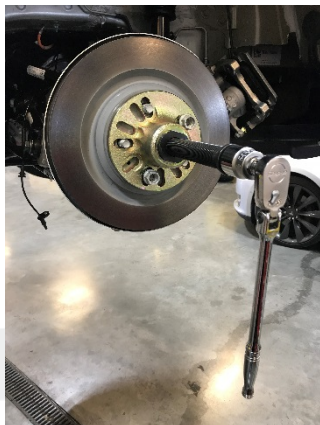
Figure 3

18. Install a hub puller on the RH front hub assembly, and then free the halfshaft from the hub splines (Figure 3).

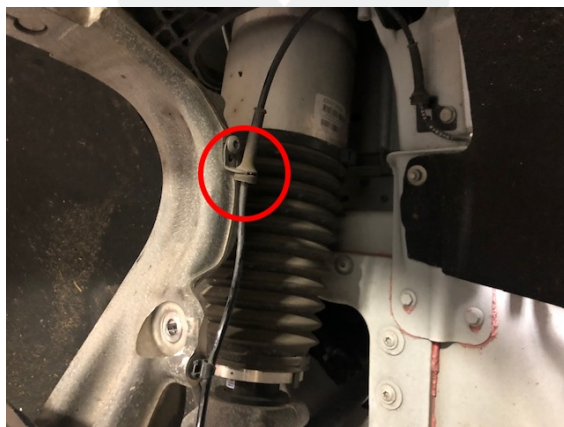
Figure 4

19. Release the grommet that attaches the RH wheel speed sensor to the RH front knuckle (Figure 4).

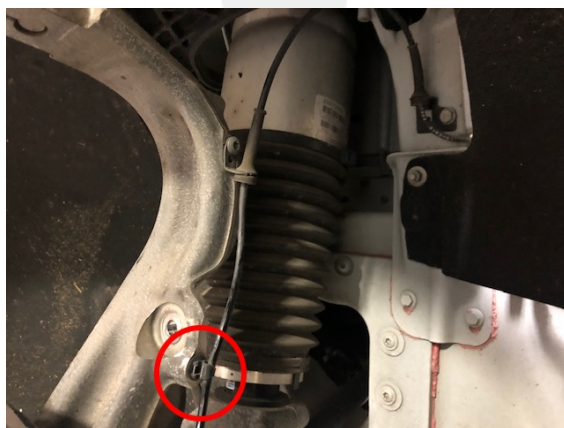
Figure 5

20. Release the clip that attaches the RH wheel speed sensor to the RH front knuckle (Figure 5).

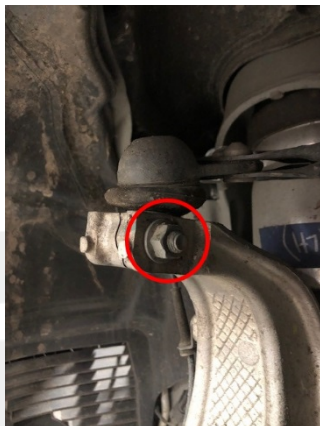
Figure 6

21. Remove the bolt and discard the nut that attaches the RH front knuckle to the RH front upper control arm (torque 60 Nm) (Figure 6).

NOTE: The nut must be discarded and replaced with a new nut. The bolt may be reused.

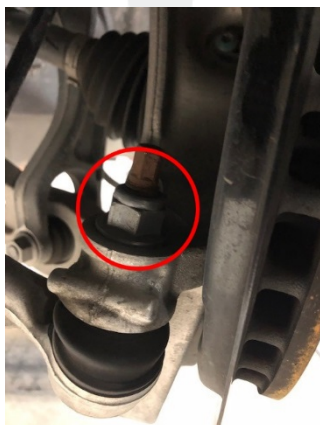
Figure 8

23. Remove and discard the nut that attaches the RH tie rod end to the RH front knuckle (torque 103 Nm), and then swing the tie rod end away from the knuckle (Figure 8).

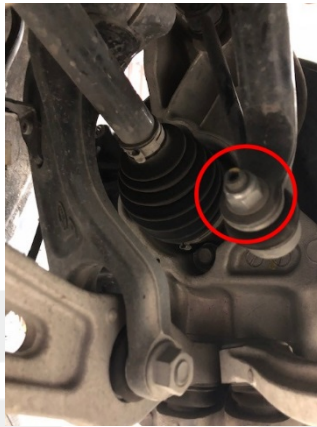
Figure 9

24. Remove and discard the nut that attaches the stabilizer bar to the stabilizer bar end link (torque 70 Nm), and then swing the end link away from the stabilizer bar (Figure 9).

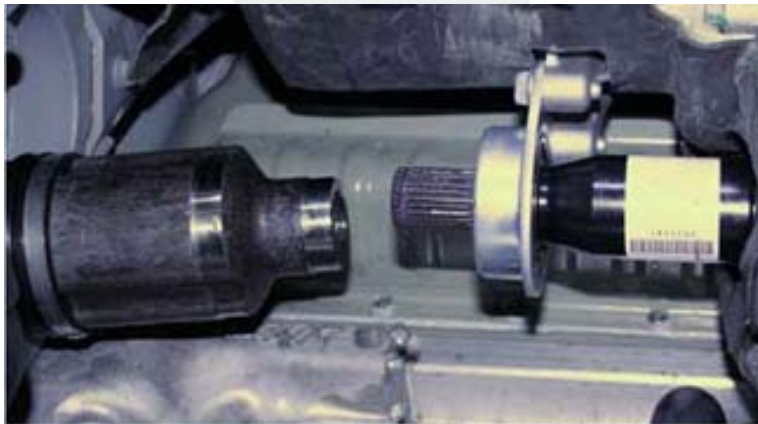
Figure 10

25. Remove the RH front halfshaft from the RH front hub assembly.
26. Use the cable axle remover to remove the RH front halfshaft from the RH front jackshaft (Figure 10).

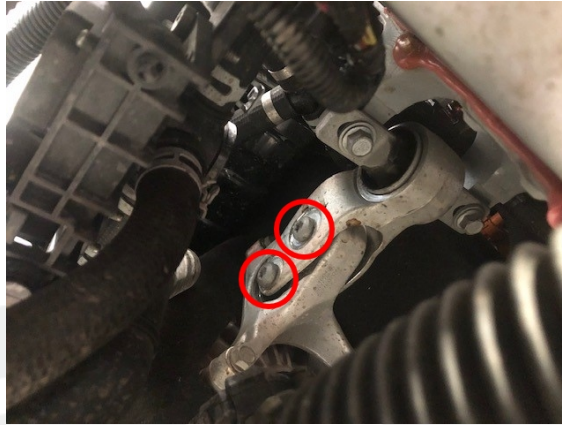
Figure 13

31. Remove and discard the bolts and patched nut plate that attach the LH front drive unit clevis mount to the isolator (torque 50 Nm) (Figure 13), and then remove the clevis mount from the vehicle.

32. Position the new LH front drive unit clevis mount on the vehicle, and then install the new bolts that attach the clevis mount to the isolator (torque 50 Nm) (Figure 13).

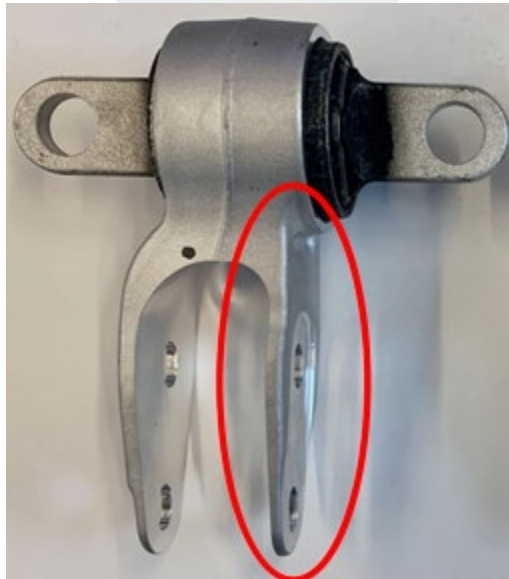
Figure 14

NOTE: The flat side of the clevis mount (Figure 14, circled) faces the rear of the vehicle.
